Road impacts to an alpine wetland complex: Summit Lake Park, Colorado

Dr. Jeremy R. Shaw and Dr. David J. Cooper Department of Forest and Rangeland Stewardship Randall Bonnell and Dr. Daniel McGrath Department of Geosciences

Mount Evans Highway (SH 5)

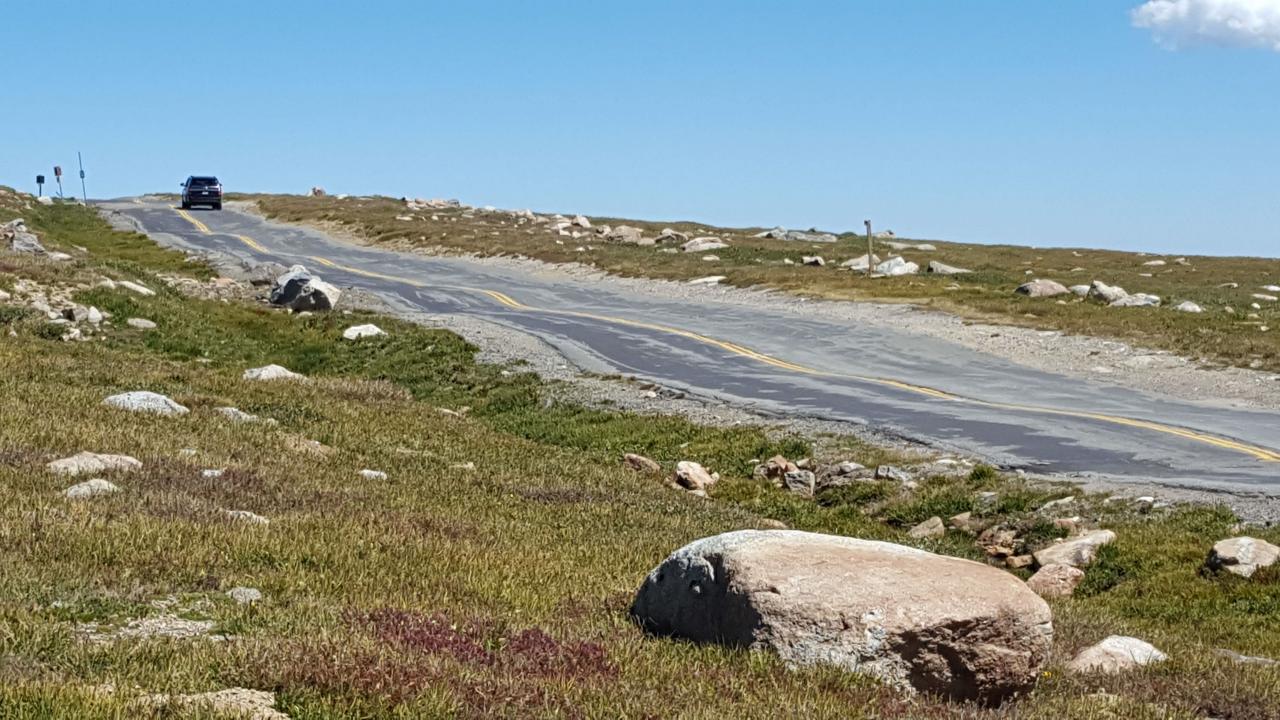
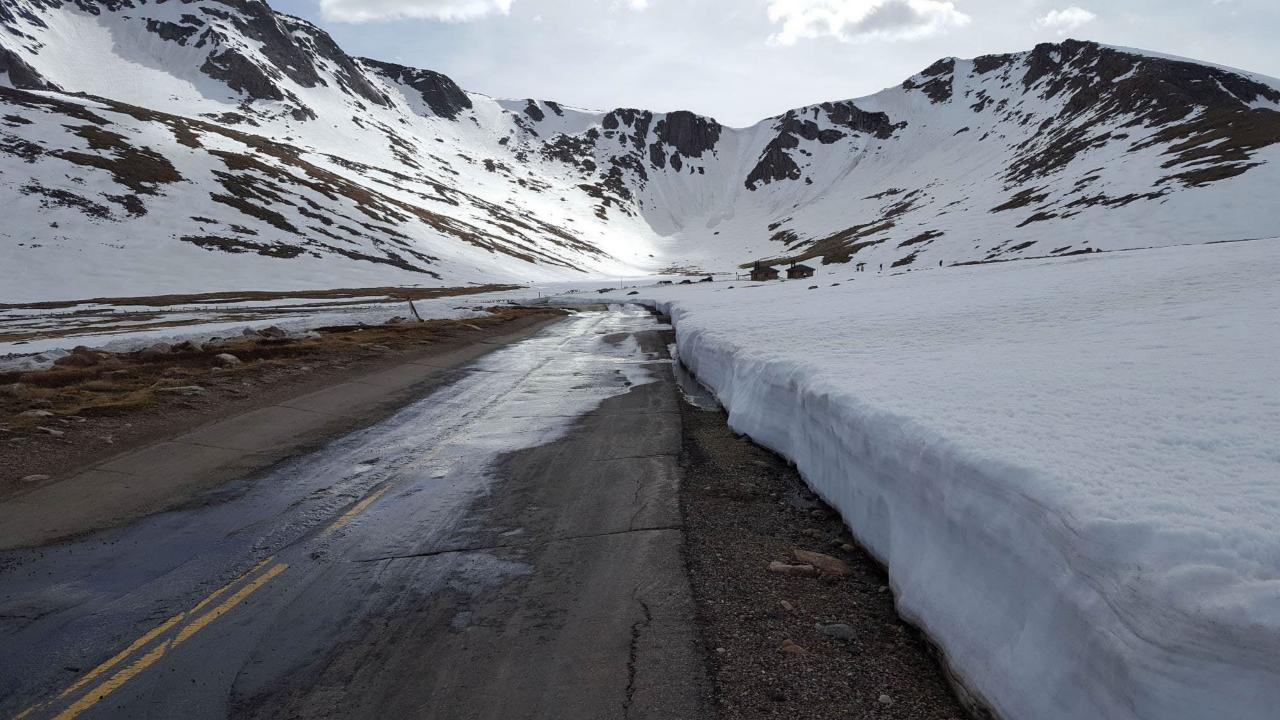
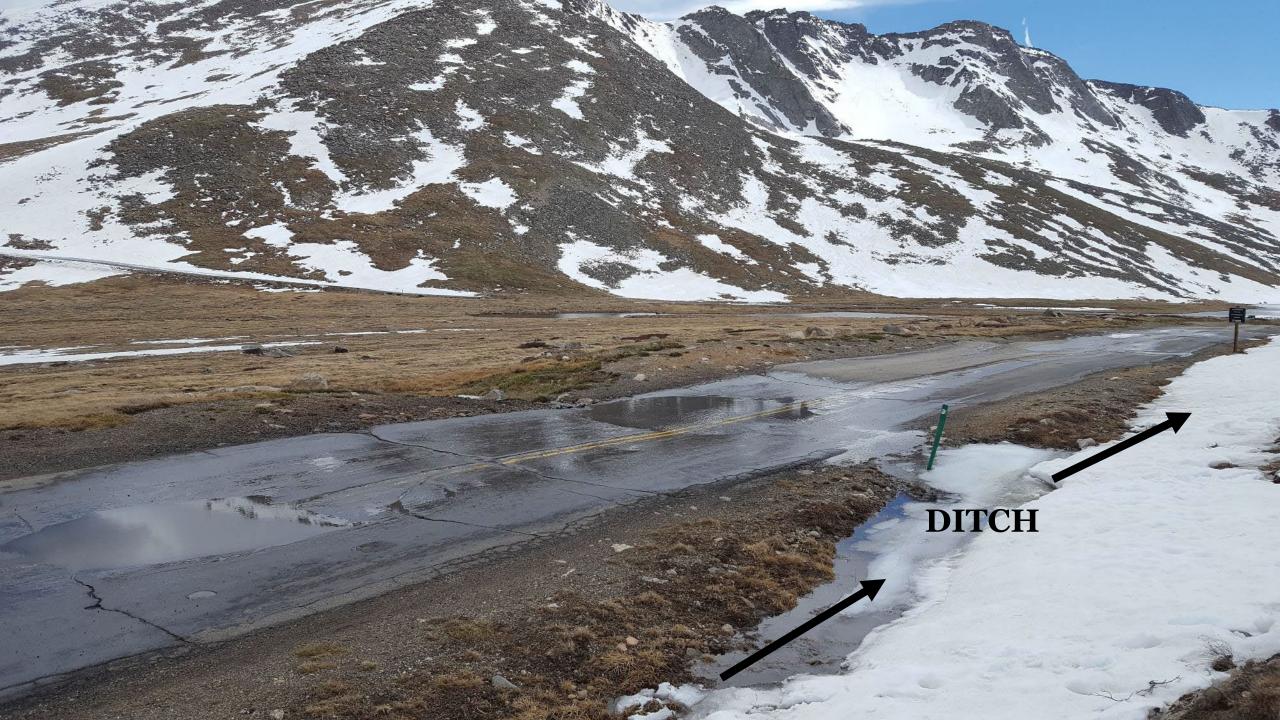
- Highest paved road in North America
- Construction began 1923, paved with asphalt in 1950s
- Permafrost melting beneath SH5
 - Ground subsidence (~1 m)
 - Buckling, warping
- Severe freeze/thaw damage
- Reconstruction required!
 - Stakeholders suspected ongoing impacts to wetland complex
 - Redesign to protect permafrost and wetland complex

- Pavement and water increase heat transfer into the ground
 = increased thaw depth
- Uninsulated roadways & ditches can create seasonal thaw ribbon = potential groundwater drain

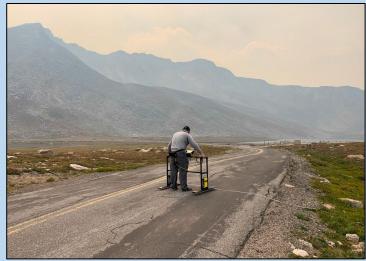
Altered Thaw Depth

- ~2 m deep outside of road corridor
- Thaw ribbon 3-6 m deep below road & ditch
- Groundwater diversion

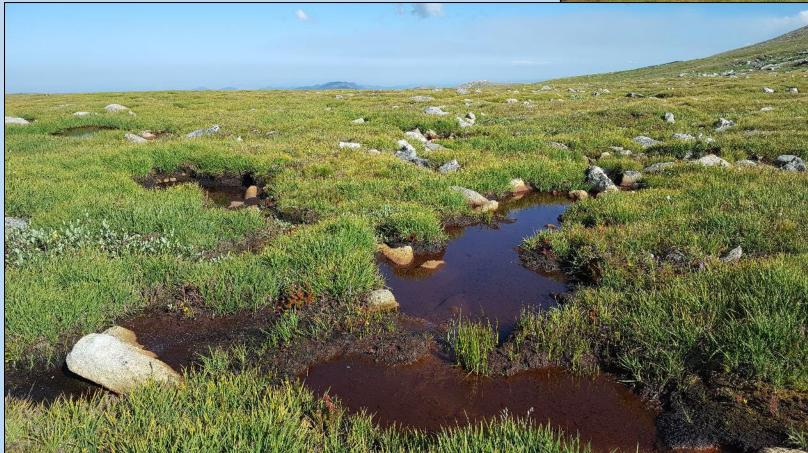
Reference pools with organic soil

Pool bottoms = algal mat or Sarmentypnum sarmentosum (moss)

Pool sides & turf = *Carex-Psychrophila*, many others

Reference pools dry in late summer,
 but moss-covered bottoms indicate
 functional sites

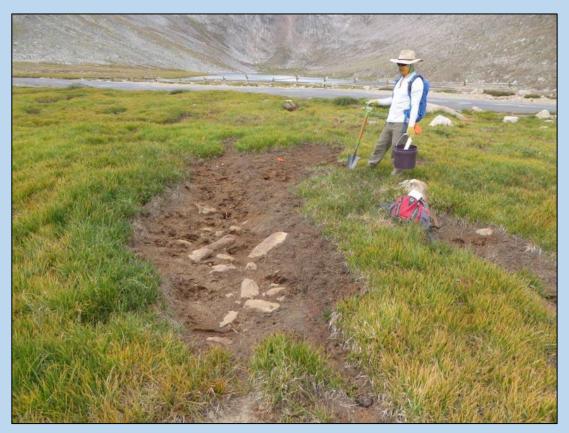
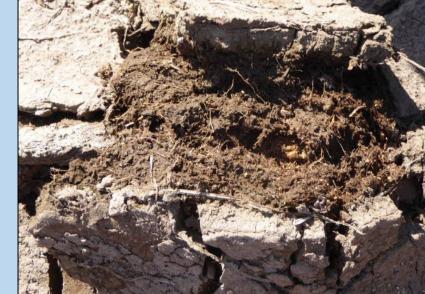
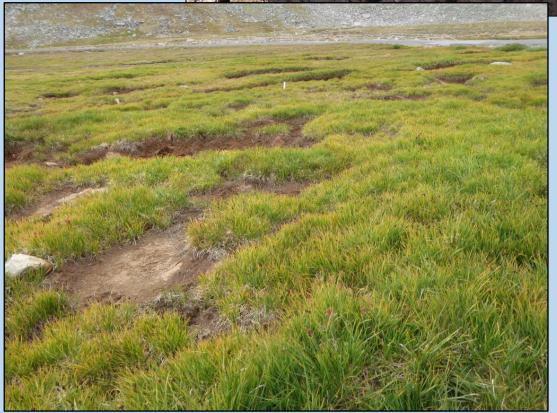
Flooded pools at culvert outfalls

Pool bottoms = bare soil and litter Pool sides = dead *Carex scopulorum* Turf = *Carex scopulorum* monoculture

*May be the most disturbed part of the study area

Flooded = moss and vascular plants replaced by bare soil with dead Carex margins

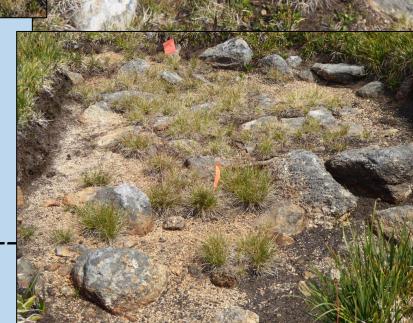
Dried Pools: Unvegetated

Pool bottoms = bare sediment Pool sides = bare sediment, eroding Distribution of Pool Types (n = 1,429)

Dried = moss replaced by vascular plants or bare
