Restoring Habitat Connectivity

S I-25 Gap Project- Using Beaver Dam Analogs to Restore Preble's Meadow Jumping Mouse Habitat

S I-25 Gap Project Background

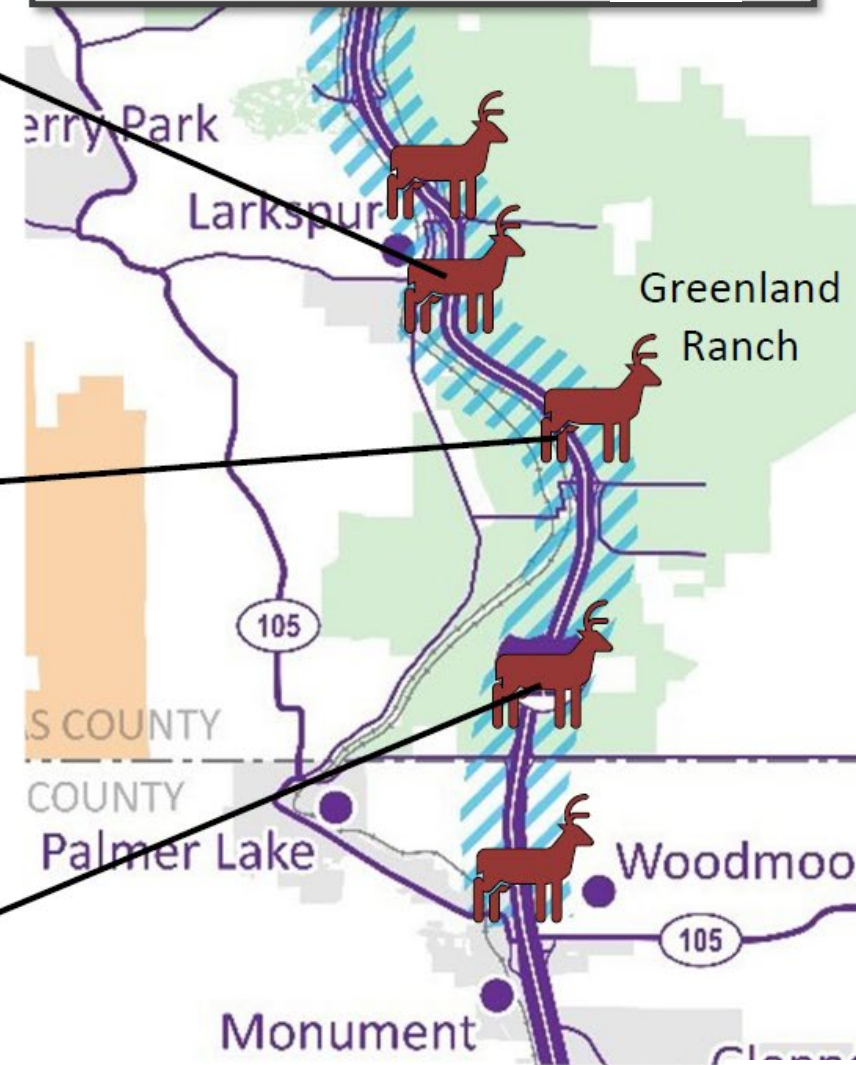
MP 164.4, just north of County Line Rd
May 2020

All five of the wildlife underpasses are substantively complete. Final planting will occur through the fall of 2022

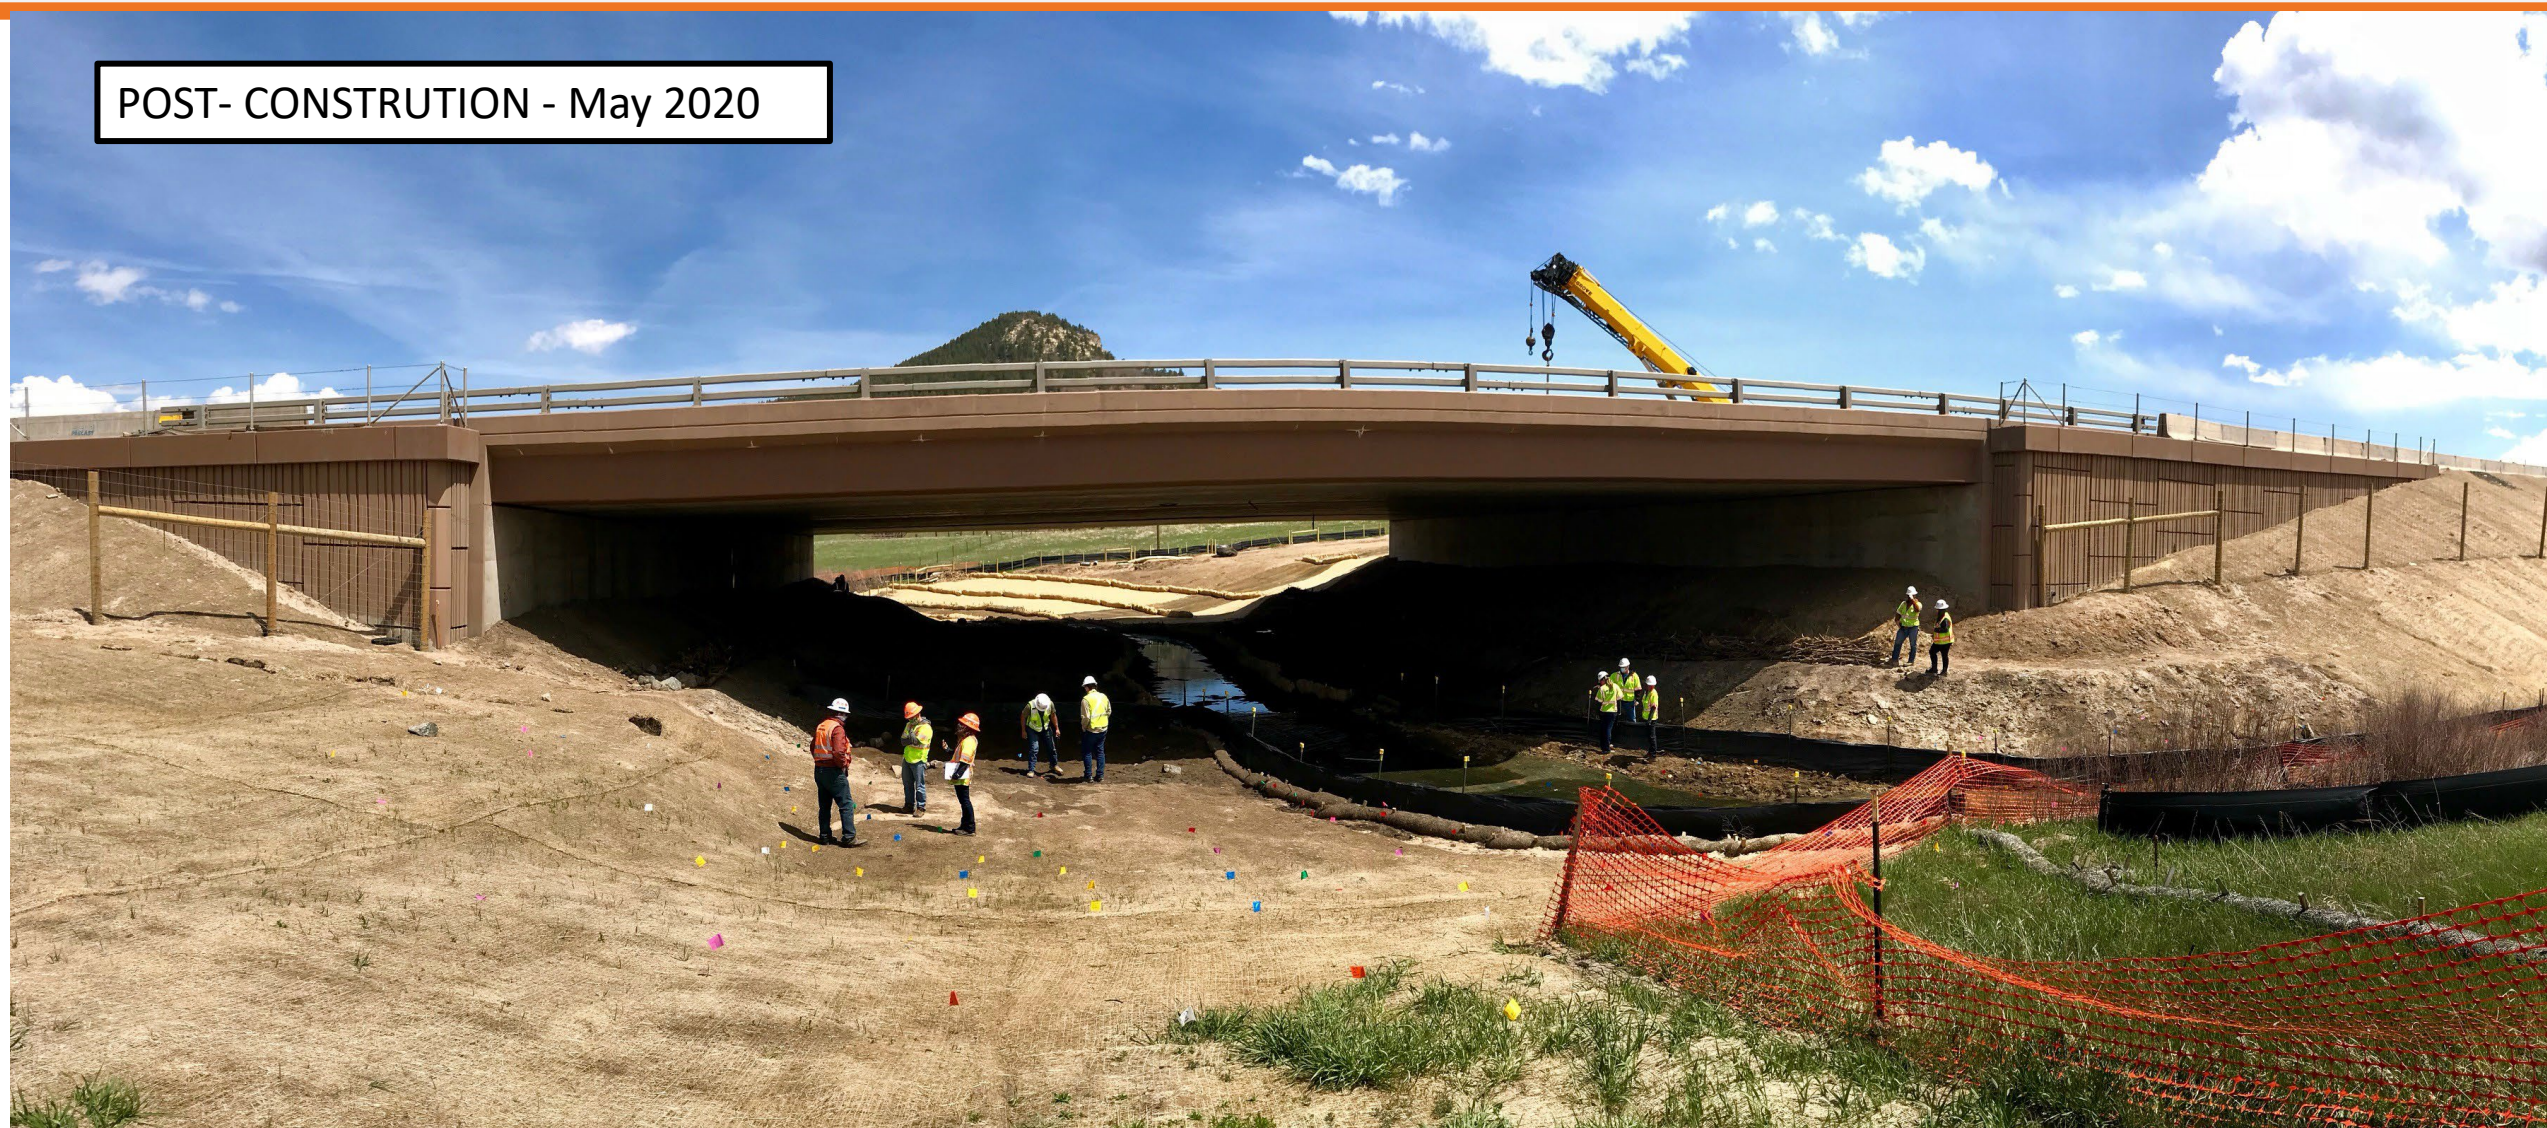
Upgraded to this Wildlife Underpass!

POST- CONSTRUCTION - May 2020

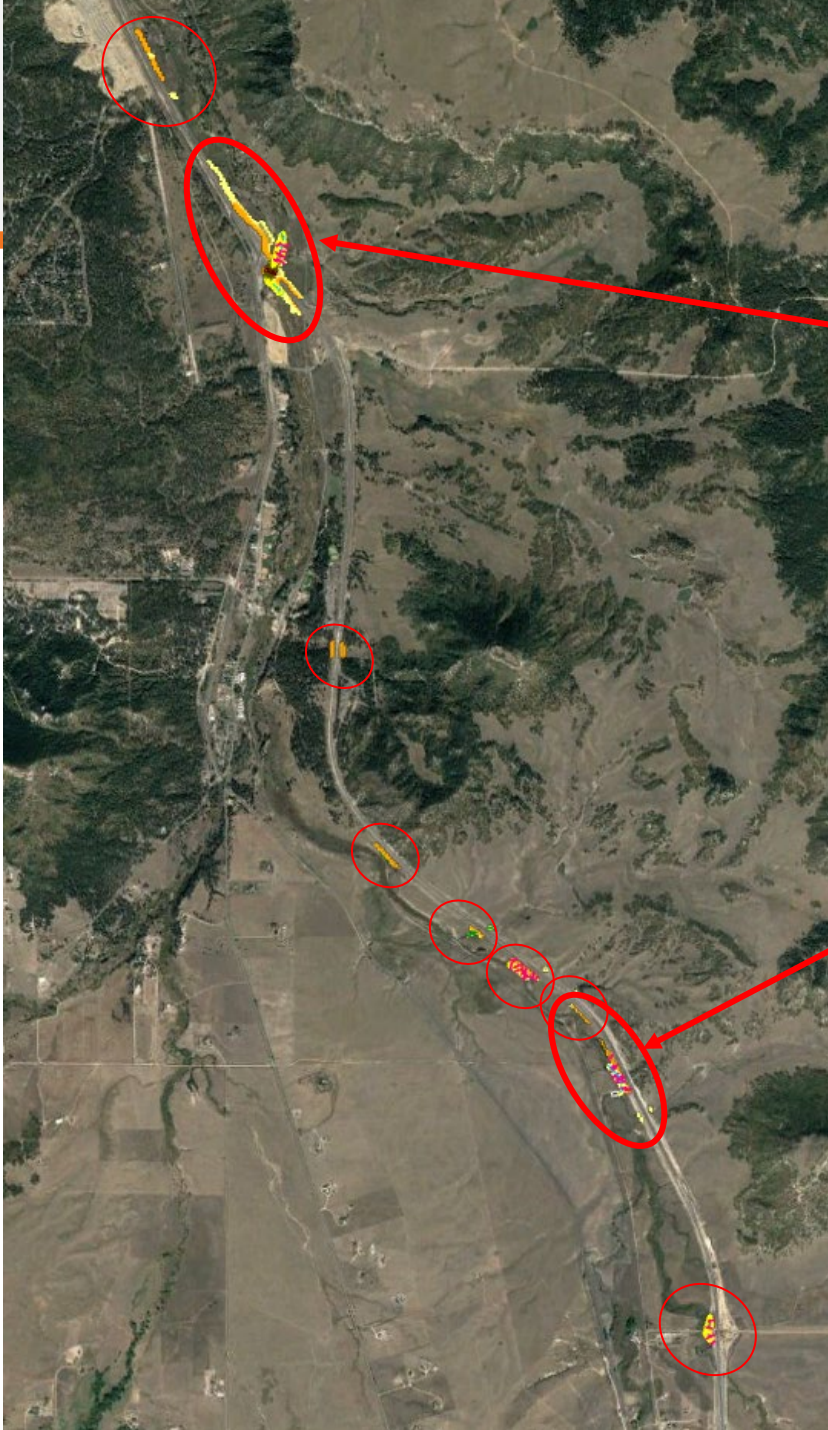
Area #3 - BDAs on East Plum Creek

Area #1 - BDAs on Carpenter Creek

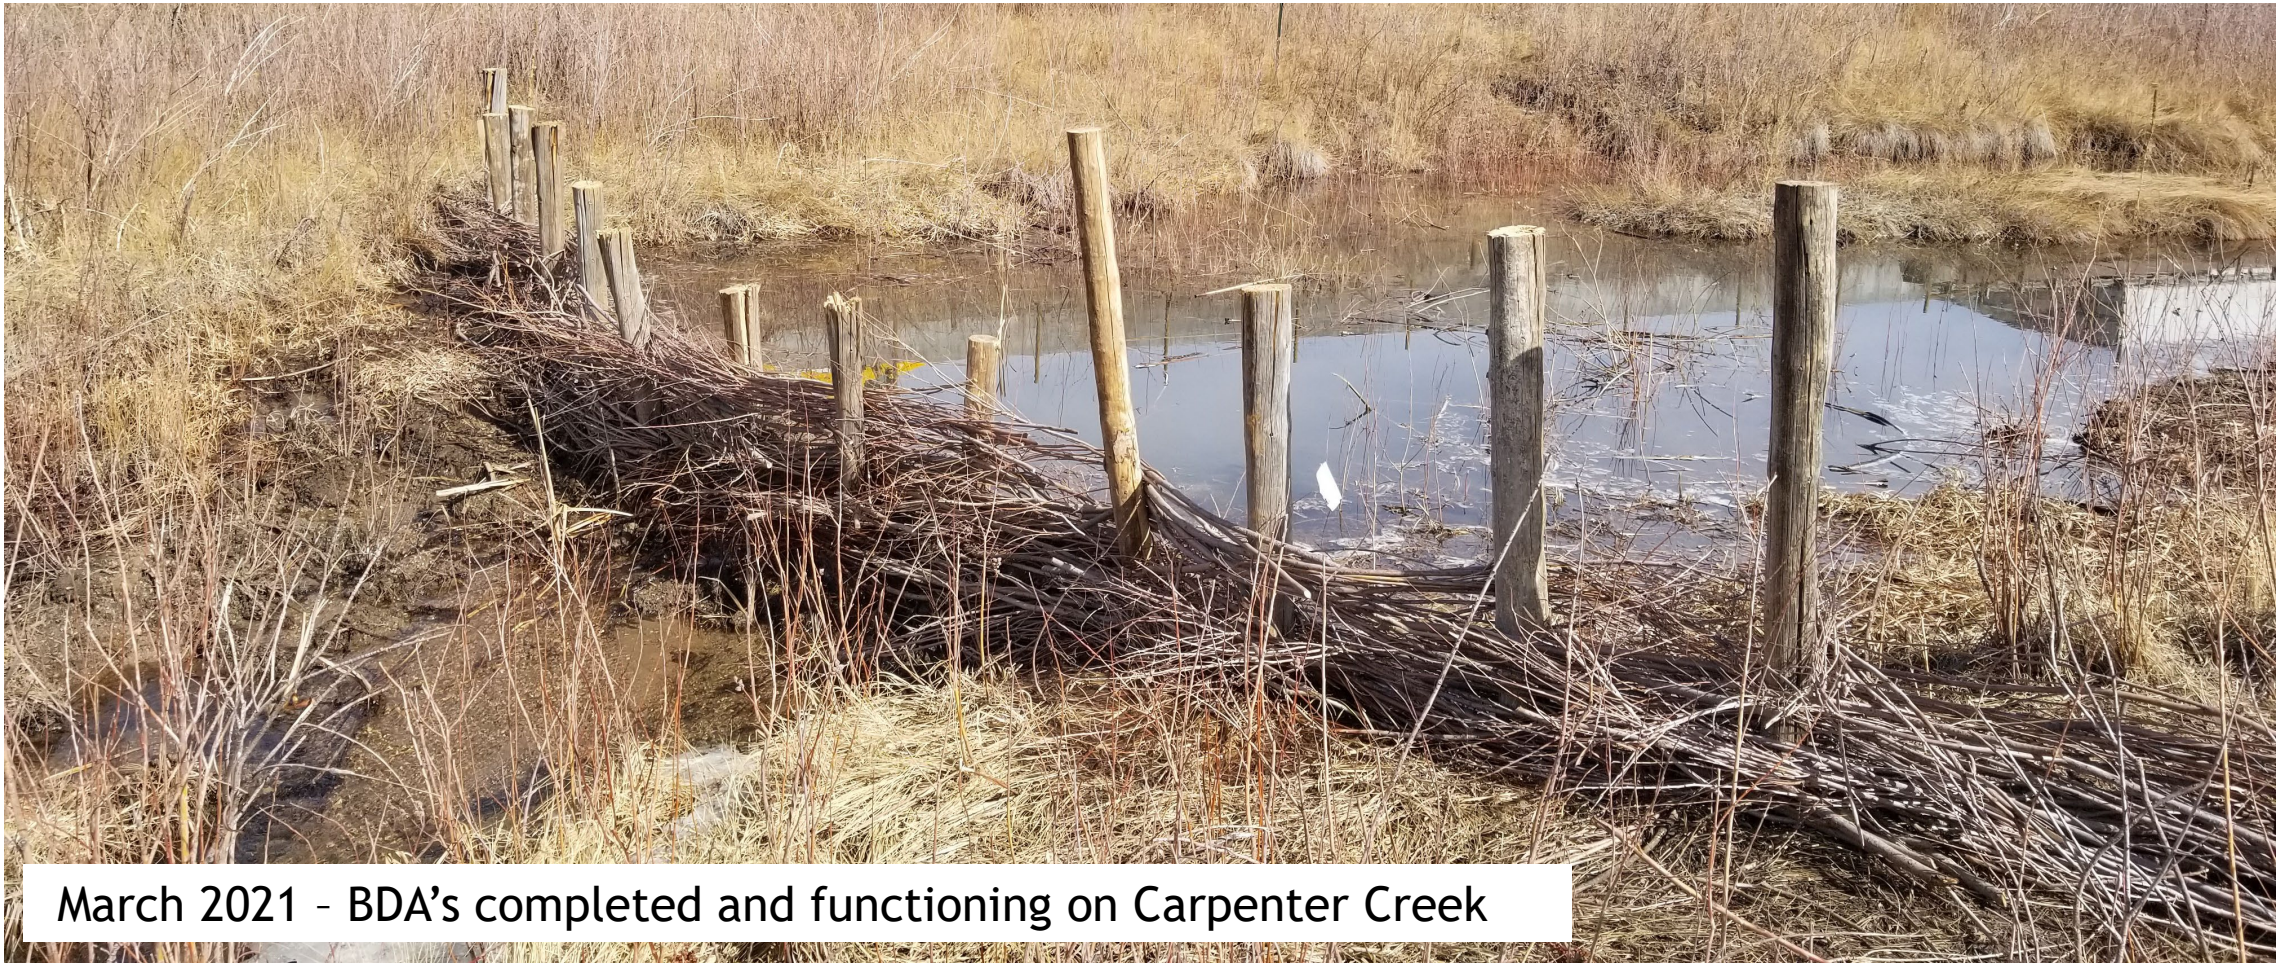
March 2021 - BDA's completed and functioning on Carpenter Creek

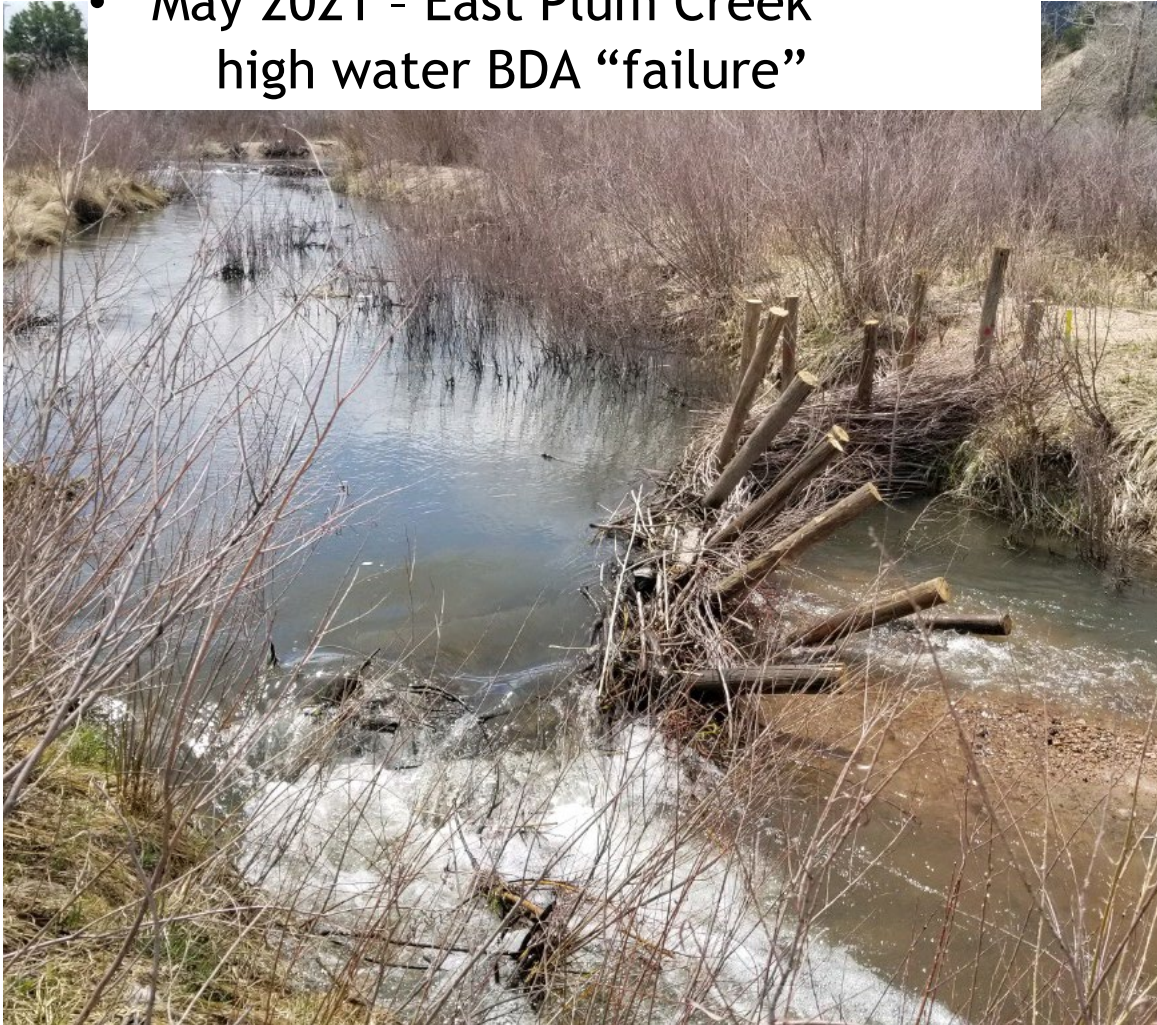
- May 2021 - East Plum Creek high water BDA “failure”

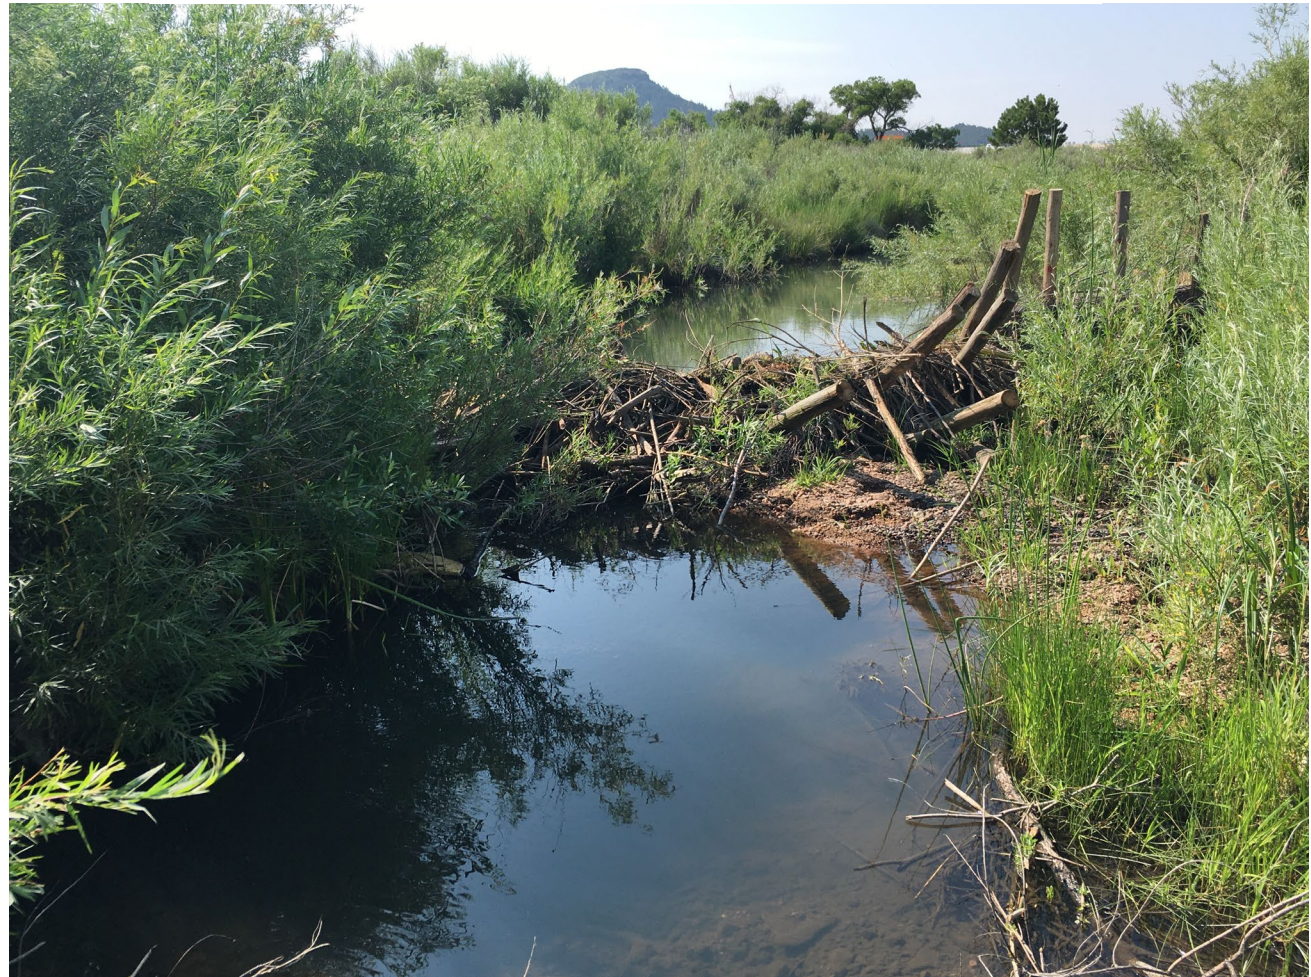
- July 2021 - beavers to the rescue

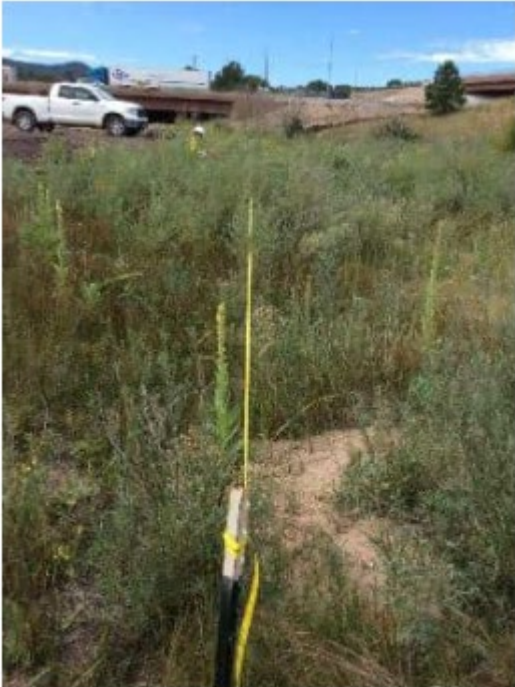
T3-H

Vegetation Transects

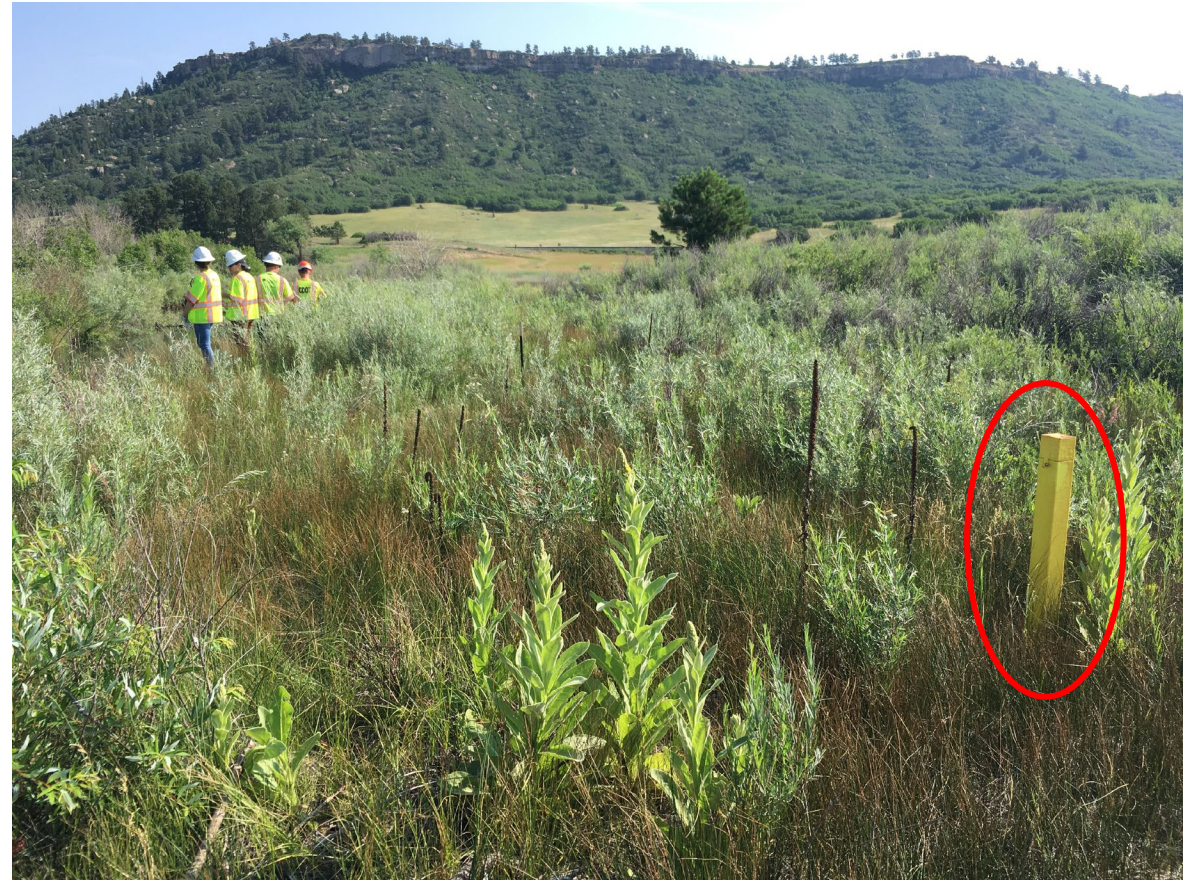
Site 1 (Carpenter Creek)

Groundwater Monitoring

Hydrology^d	Groundwater monitoring wells will be installed to record groundwater levels throughout the growing season.	<ul style="list-style-type: none"> In restored PMJM Areas (BDA locations) the depth of groundwater below the surface elevation will be within 30 inches of the soil surface for a minimum of 18 consecutive days, which equals 12.5% of the growing season (May 9 through Oct. 2, 147 days) for a minimum of two years in normal water years^e. Restored PMJM Areas (excluding stream channel) will also not have standing water for greater than 18 consecutive days during the same growing season.

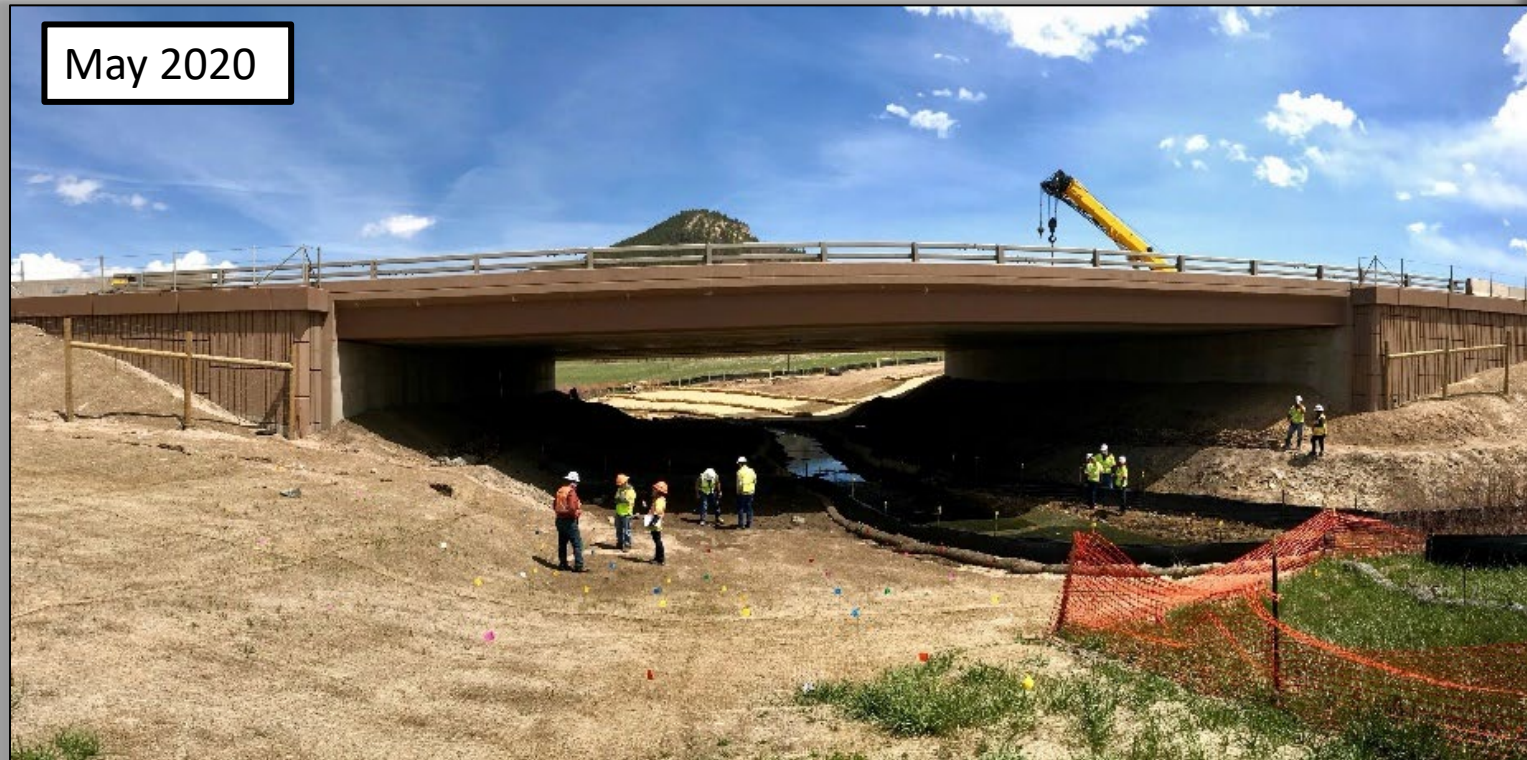
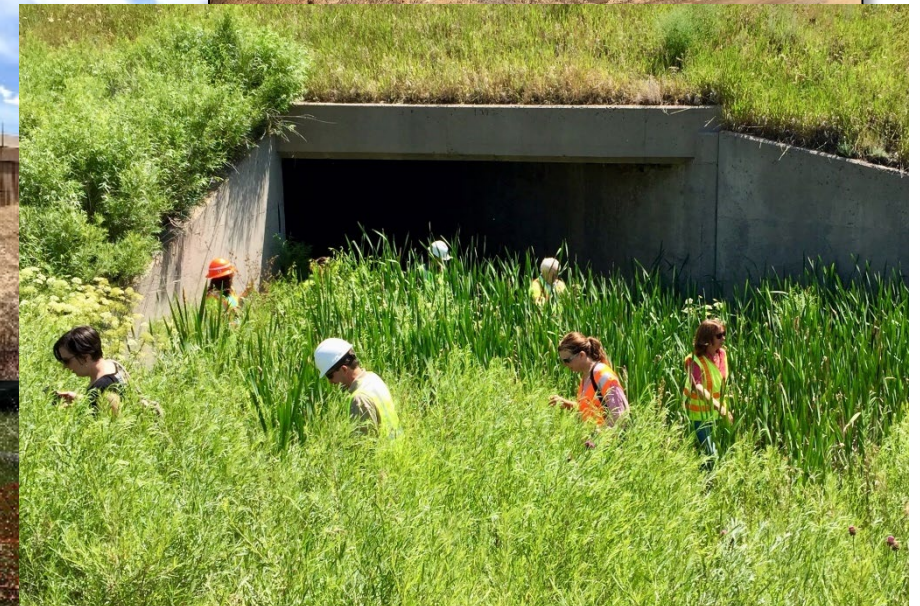
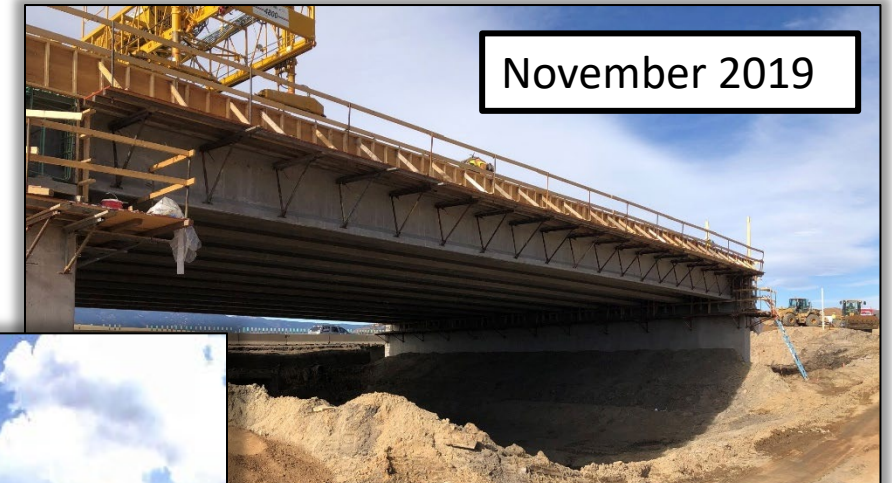
Wildlife Underpass Construction

Span bridge structures were selected as the best structure type. Four new wildlife underpasses and one reconstructed large bridge have been constructed in the project area.

The wildlife underpass openings measure approximately 18' high by 100' wide, helping to restore wildlife migration between the two largest preserved open space properties that are bisected by I-25
